[Docket No. FAA-2018-0479; Product Identifier 2016-NE-23-AD; Amendment 39-19369; AD 2018-17-15]

Airworthiness Directives; Honeywell International Inc. Turboprop and Turboshaft Engines

ACTION: Final rule.

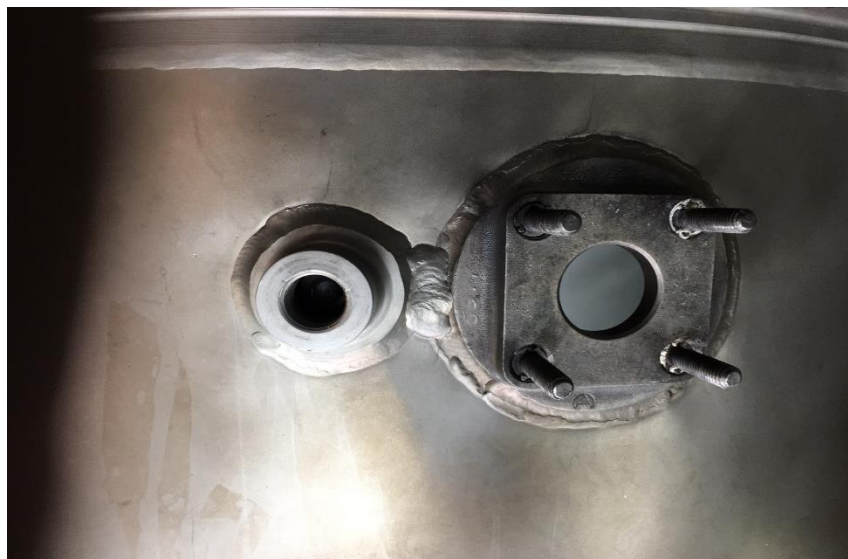
Figure 1 to Paragraph (h) of this AD. Combustion Chamber Case Assembly Without the One-Piece Bleed Pad with P3 Boss

(2) For TPE331-3U, -3UW, -5, -5A, -5AB, -5B, -6, and -6A engine models with combustion chamber case assemblies, P/Ns 869728-1, 869728-3, or 893973-5, installed, and without the one-piece bleed pad with P3 boss; and for TPE331-1, -2, and -2UA

engine models modified by National Flight Services, Inc., supplemental type certificate (STC) SE383CH, remove the combustion chamber case assembly from service at the next removal of the combustion chamber case assembly from the engine, not to exceed 3,700 hours TIS since last hot section inspection.

(2) Figures 1 and 2 to paragraph (h) of this AD illustrate the appearance of combustion chamber case assembly, P/N 893973-5, without and with, respectively, the one-piece bleed pad with the P3 boss.

After the effective date of this AD, do not install a combustion chamber case assembly, P/N 869728-1, 869728-3, or 893973-5, in TPE331-3U, -3UW, -5, -5A, -5AB, -5B, -6, and -6A engine models or in TPE331-1, -2, and -2UA engine models modified by National Flight Services, Inc., STC SE383CH, unless the combustion chamber case assembly has a one-piece bleed pad with P3 boss.
